# TECHNICAL INFORMATION

63132

**Subject** ▶ Change of Ball Bearing

**For Models** ▶ 5017RKB

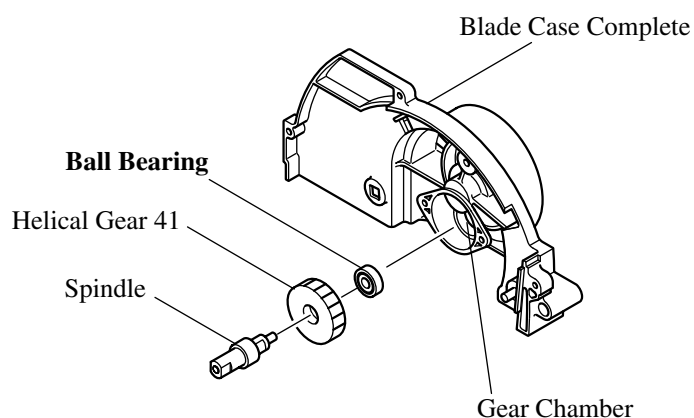
**Description** ▶ For quick repairing, the Ball Bearing in the gear chamber of Blade Case Complete has been changed from 608DDW (double sealed type) to 608 (seal-less type).  
(It is difficult to put a double sealed ball bearing in the gear chamber when there is much grease inside the gear chamber.)

| | ▶ <b>Current</b> | ▶ <b>New</b> |
| Cat. No.<br>of Ball Bearing | 608DDW<br>(With seals on both sides) | 608<br>(No seals on either side) |
| Part No. | 210005-4 | 211034-0 |
