**Subject** ▶ Change on blade case and rubber ring

**For Models** ▶ 5903R and 5903

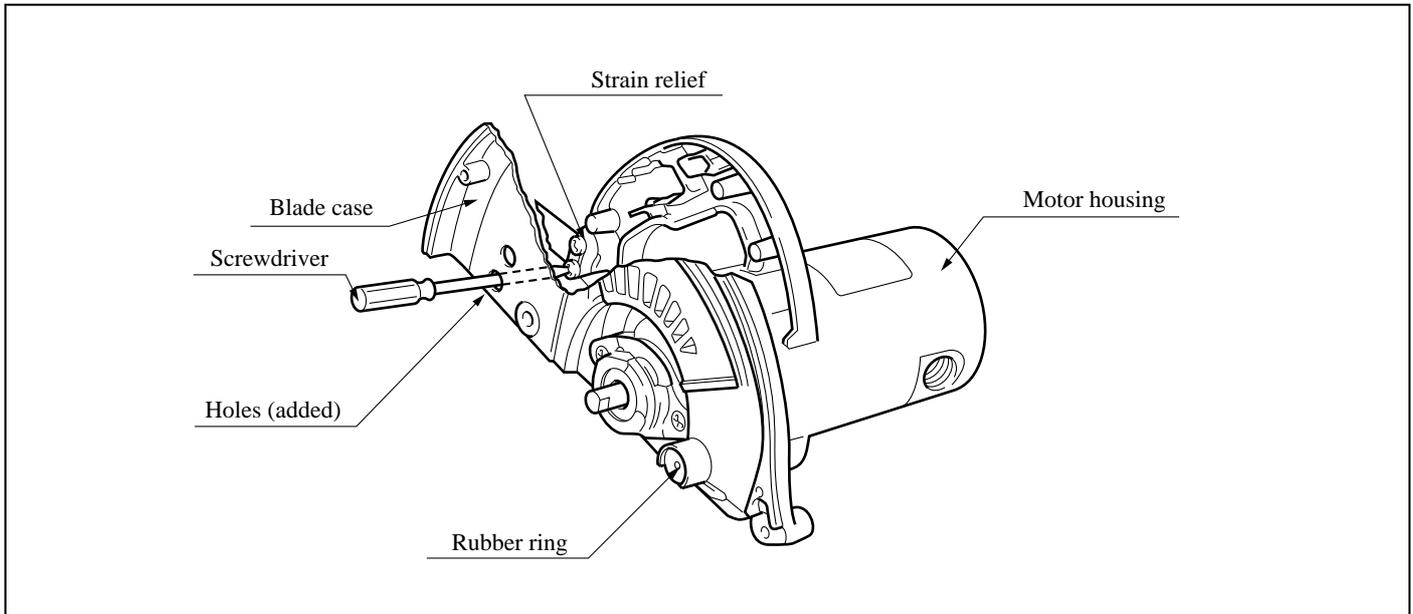
**Description** ▶ 1. Two holes will be made in the blade case. As shown in the figure below, the strain relief securing screws can be loosened by inserting a screwdriver through the holes in the blade case. It is not necessary to remove the blade case from the motor housing when removing the strain relief.

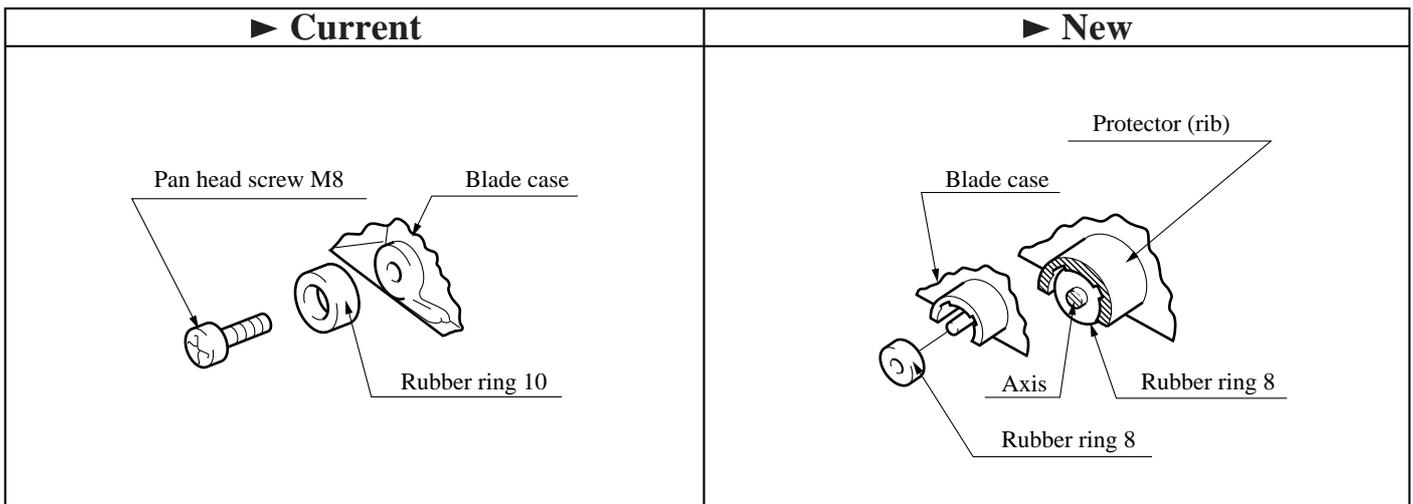
2. To increase the durability of the rubber ring which supports the safety cover (safety guard), the rubber ring 10 will be replaced by a rubber ring 8. An axis and protector (rib) for the rubber ring 8 will be added to the blade case. The pan head screw M8 (rubber ring securing screw) will be discontinued.

Install the rubber ring 8 so that its top surface is below that of the protector (rib).
