# TECHNICAL INFORMATION

- Subject** ▶ Change of Tapping Screws, Gear Housing Complete
- For Models** ▶ 9015A, 9015B, 9015DB, 9016B, 9016DB
- Country** ▶ All countries
- Description** ▶ Tapping Screws Mx16 for securing Bearing Box to Gear Housing Complete have been replaced by Pan Head Screw M5x16. Accordingly, Gear Housing Complete has been changed as shown below.

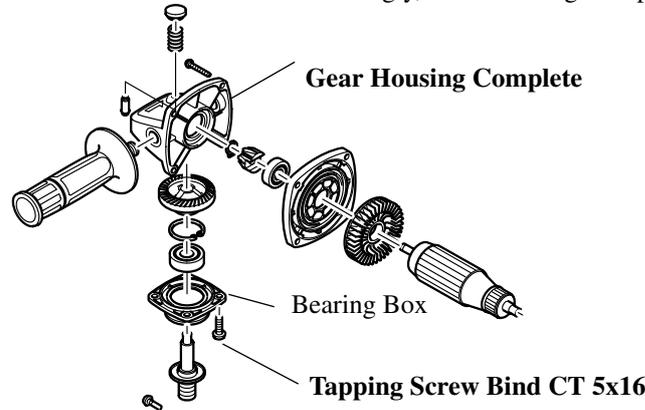
▶ Current	▶ New
<p><b>Tapping Screw CT5x16</b> (266027-2)</p>	<p><b>Pan Head Screw M5x16</b> (265096-0)</p>
<p><b>Gear Housing Complete</b> (159995-5)</p> <p>Holes are <b>not</b> threaded inside.</p>	<p><b>Gear Housing Complete</b> (153374-9)</p> <p>Holes are threaded inside.</p>

Note: When re-fastening the current screws on the current Gear Housing Complete so as not to be loosened, apply adhesive (Lock Tite 242 50G, Part No. 0405065-5A) inside the holes on the current Gear Housing Complete. When replacing the current Gear Housing Complete with the unused current Gear Housing Complete, apply a bit of the above adhesive inside those holes only after making threaded holes by screwing the tapping screws in the holes.
