- Subject** ▶ Change of Center Plate and Link Plate
- For Models** ▶ BLS712, BLS820, LS0711, LS0711B, LS0711Z, LS0713, LS0811, LS711D, LS800D
- Country** ▶ All countries
- Description** ▶ Surface treatment of Center plate and Link plate have been changed as described below.

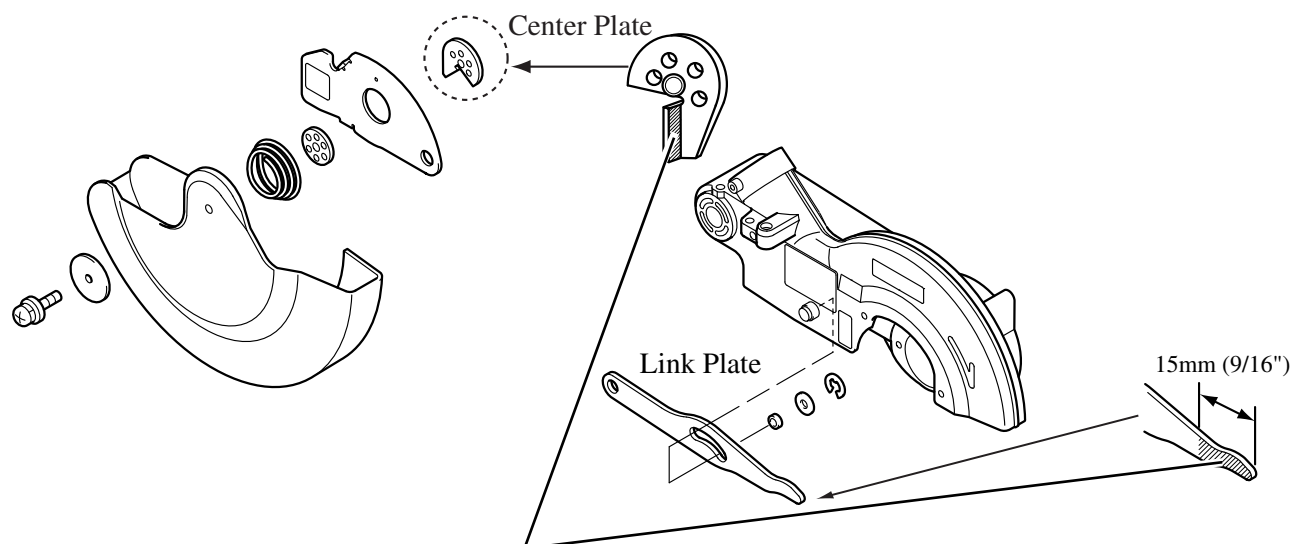
Surface treatment of Center plate and Link plate

▶ Current	▶ New
Disulfide Molybdenum	$\alpha$ coating

Item No.	Current part		Q'ty	I/C	New part		Q'ty	Note
See below.	Center Plate 344640-7		1	←	Center Plate 345410-7		1	
See below.	Link Plate 344999-2		1	←	Link Plate 345411-5		1	BLS712, LS0711, LS0711B LS0711Z, LS0713, LS711D
See below.	Link Plate 344786-9		1	←	Link Plate 345412-3		1	LS0811
003	Safety Cover Assembly 134932-0		1	←	Safety Cover Assembly 135061-2		1	LS0711
048	Safety Cover Assembly 134933-8		1	←	Safety Cover Assembly 135062-0		1	LS0811
