# T ECHNICAL INFORMATION

- Subject** ▶ Change of Bumper
- For Models** ▶ 6905H
- Country** ▶ All countries
- Description** ▶ As illustrated below, Bumper has been changed for standardization.  
The new Bumper is identical with that of Model SI100.

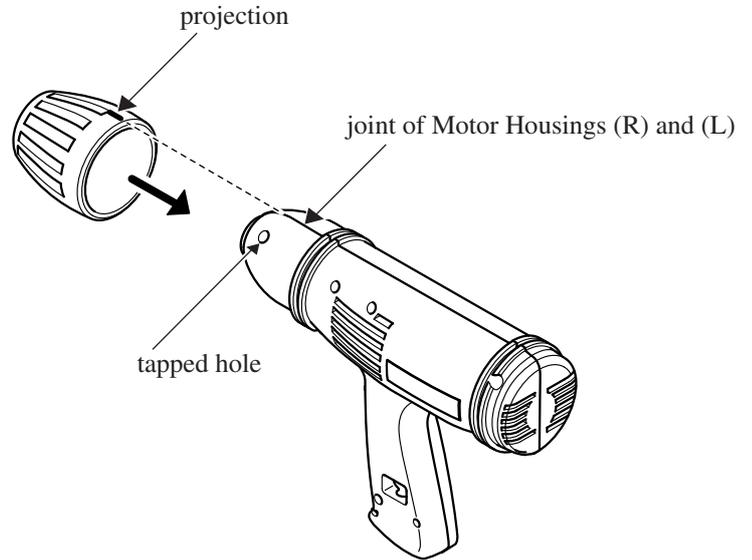
**How to set the new Bumper in place:**

Aligning the projection on Bumper with the joint of Motor Housings (R) and (L) as illustrated on right, push Bumper until its inner bosses are securely put in the tapped holes of Motor Housing.
