T ECHNICAL INFORMATION

57432

- Subject** ▶ Changes on Gear Housing Complete and Screw
- For Models** ▶ 9060L, 9067, 9067L, 9067S, 9069, 9069S
- Country** ▶ All countries
- Description** ▶ As illustrated below, Gear Housing Complete and Screw have been changed for quick repair.

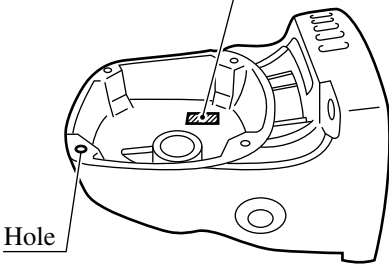
▶ Current	▶ New
Gear Housing Complete	<p>Inscription of "3170064"</p>

<p>Hole</p> <p>(Part No.150968-1)</p>	<p>Inscription of "3172414"</p>

<p>Treatment for Screw M5</p> <p>(Part No.151631-9)</p>
Screw (4pcs.)

<p>Tapping Screw (Part No.266027-2)</p>

<p>Pan Head Screw w/spring washer (Part No.911226-8)</p>

Item No.	Current part		Q'ty	I/C	New part		Q'ty	Note
9060L: 038 9067/9067L/ 9067S/9069/ 9069S: 042	Gear housing complete 150968-1		1	No	Gear housing complete 151631-9		1	Interchangeable as a set
9060L: 030 9067/9067L/ 9067S/9069/ 9069S: 034	Tapping screw bind CT 5x16 266027-2		4	No	Pan head screw M5x18 911226-8		4

These changes are implemented exclusively on machines manufactured in Japan.
