- Subject** ▶ Change of Torque Limiter Complete
- For Models** ▶ HR3000C, HR3550C, HR4040C, HR4500C
- Country** ▶ All countries
- Description** ▶ Adhesive has been applied to Pin 4 in Torque Limiter Complete to prevent the Pin 4 from coming out of place.

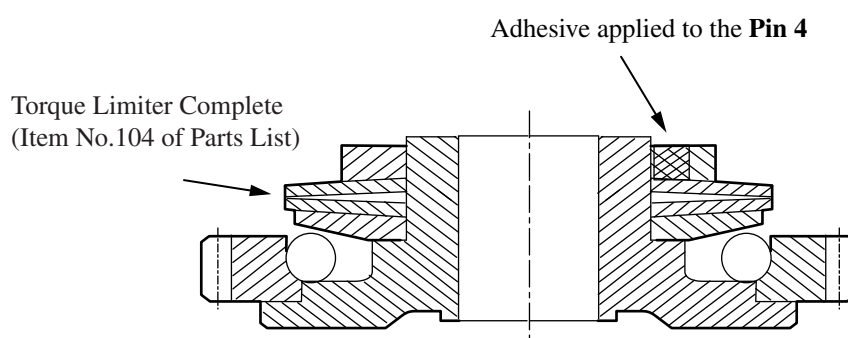
Torque Limiter without Pin 4 may cause a Round Nut to rotate, resulting in the torque out of presetting. To avoid such trouble, this addition of adhesive has been made. (However, Pin 4 in the Torque Limiter Complete which is installed on Rotary Hammers does not come out of place. Accordingly, this change is applicable to Torque Limiter as a replacement part only.)
