TECHNICAL INFORMATION

- Subject** ▶ Change of Clamp
- For Models** ▶ JR140D, JR180D, JR3000VT, JR3030T
- Country** ▶ All countries
- Description** ▶ A hole in Clamp for Pin 5.5-6 has been changed in dimensions.

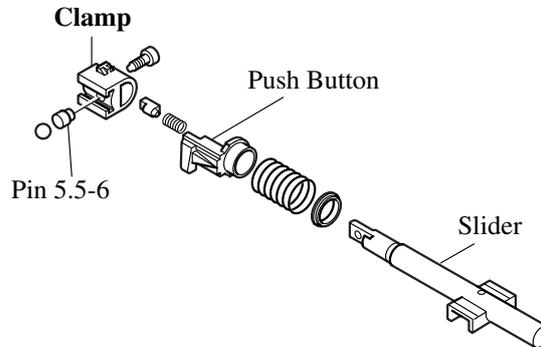
To distinguish new Clamp from current one, new Clamp has a projection as illustrated below.

▶ Current	▶ New
 Clamp (Pt. No. 310088-5)	 Clamp (Pt. No. 310138-6)

Item No.	Current part	Q'ty	I/C	New part	Q'ty	Note
See below.	Clamp 310088-5	1	←	Clamp 310138-6	1

The arrow ← means that the new part can be substituted for the current.
