SERVICE BULLETIN

RB397

RB397-MK2

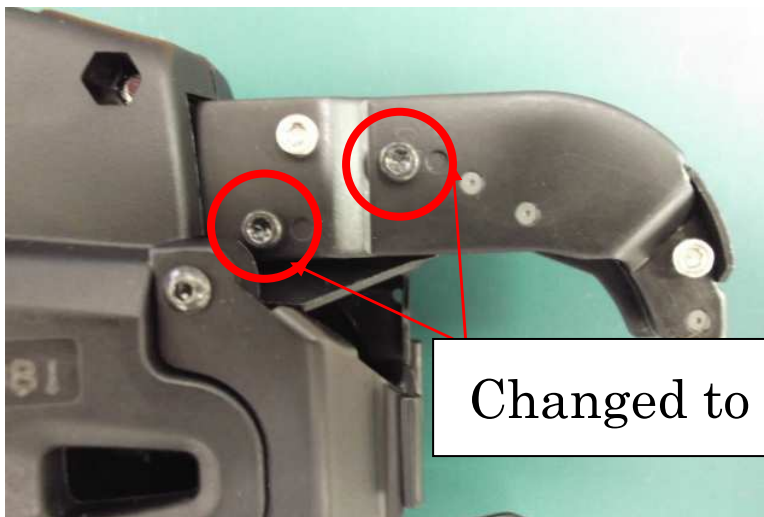
When clean up at the cutter area is required, service person should unscrew the chrome color bolts only and should not unscrew the black bolts on the Arm Cover. In order to secure this, 2 pcs of Black Hex bolt M3x5 (BB40711) were changed Torx bolt M3x5(BB86701).

Changed to Torx Type

Old Hex bolt BB40711 was discontinued.
